Tecknet Mouse Battery Mod

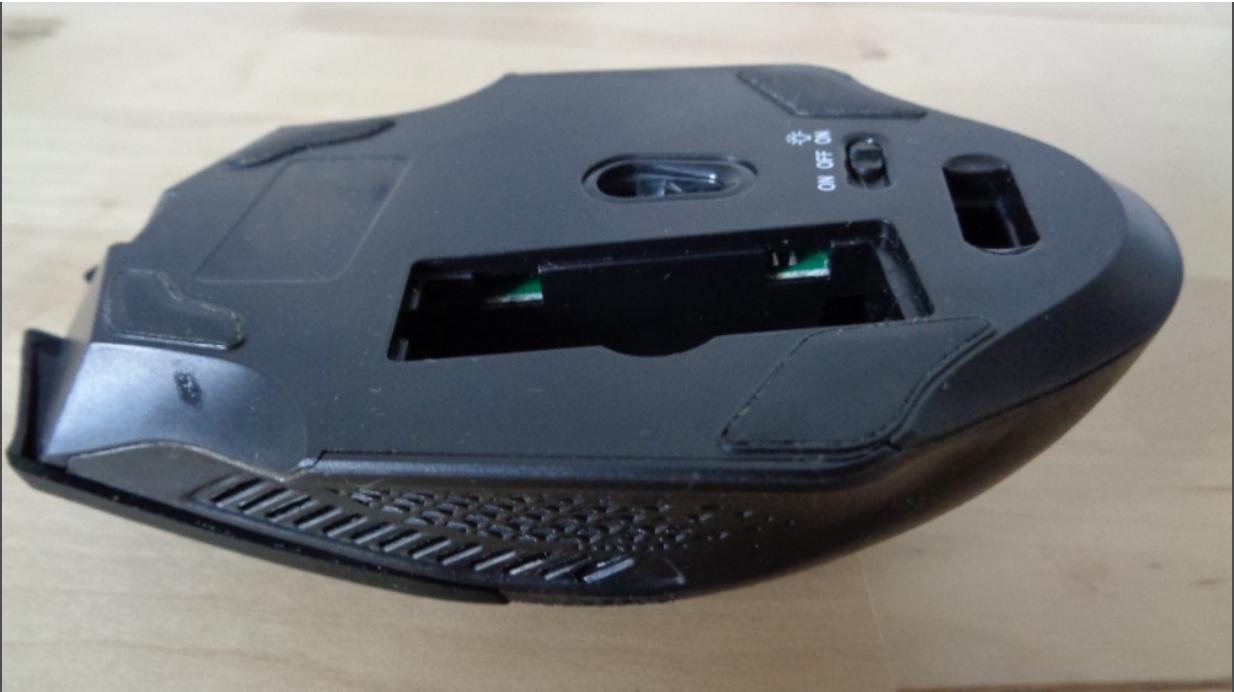
Before I start with a project I always get an overview. The battery compartment is located at the bottom and is closed with a simple plastic lid. Nothing special. At that time, I didn't know where the screws on the mouse were. First you remove all components that are not screwed. In this case this is the cover of the battery compartment.

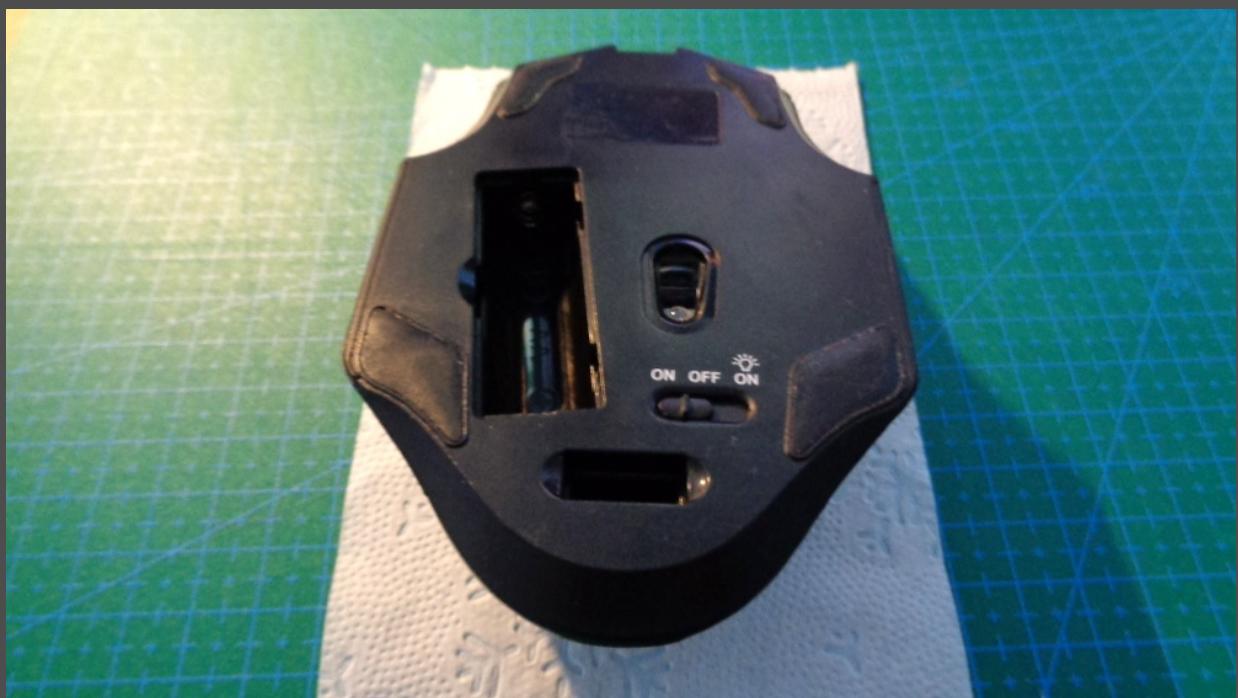
When the mouse was sent to me by mail, the bluetooth dongle was in the small compartment at the end of the mouse. Since this is a prefabricated opening, you might be able to use it for a connector. Otherwise, it's just an unnecessary waste of space that you can't use sensibly. The on/off switch and the laser can't be changed from the position and this probably also applies to the electronics inside the mouse.

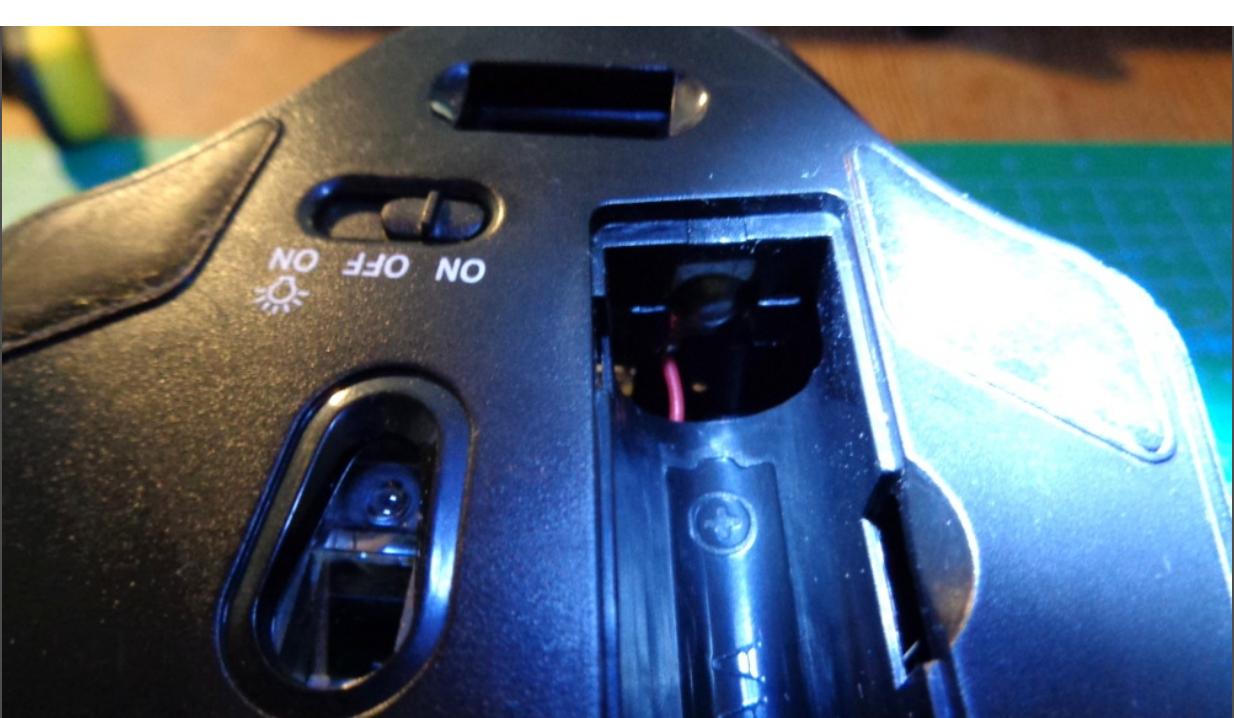
To see better you can use a small LED lamp. With this you can also look into cracks or small recesses. At the ends of the battery compartment were two metal contacts soldered with a red and a black cable. These are the power supply (GND) and (VCC), which supply the mouse with power. It's good to know that certain wires are not on the PCB, but are soldered as single cables. This is often an advantage with cheap hardware from China.

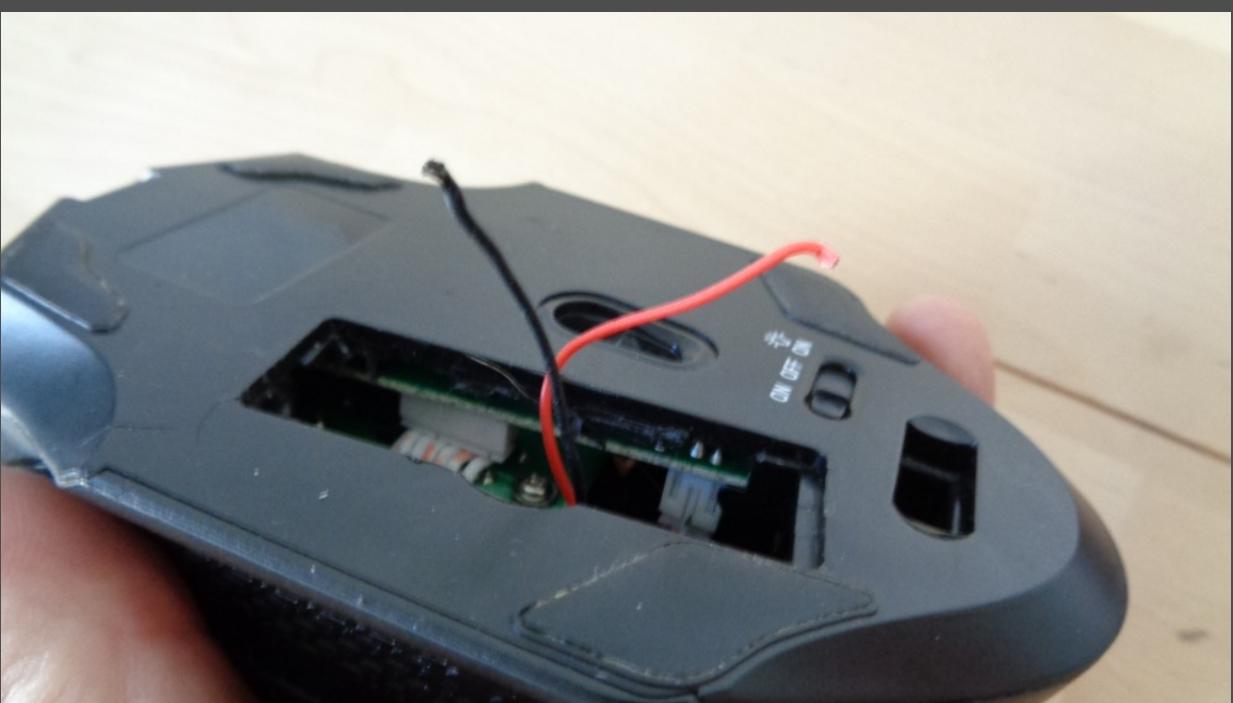
I cut off the metal contacts with a wire cutter. If necessary you can also use old scissors. Since I can now look much better into the inside of the mouse, I see two printed circuit boards altogether. One is on the upper side and regulates individual buttons there. On the lower board there is the whole rest, the mouse wheel, the left/right mouse button, the side buttons and the power supply. Both circuit boards are connected, which makes it difficult to disassemble the mouse.

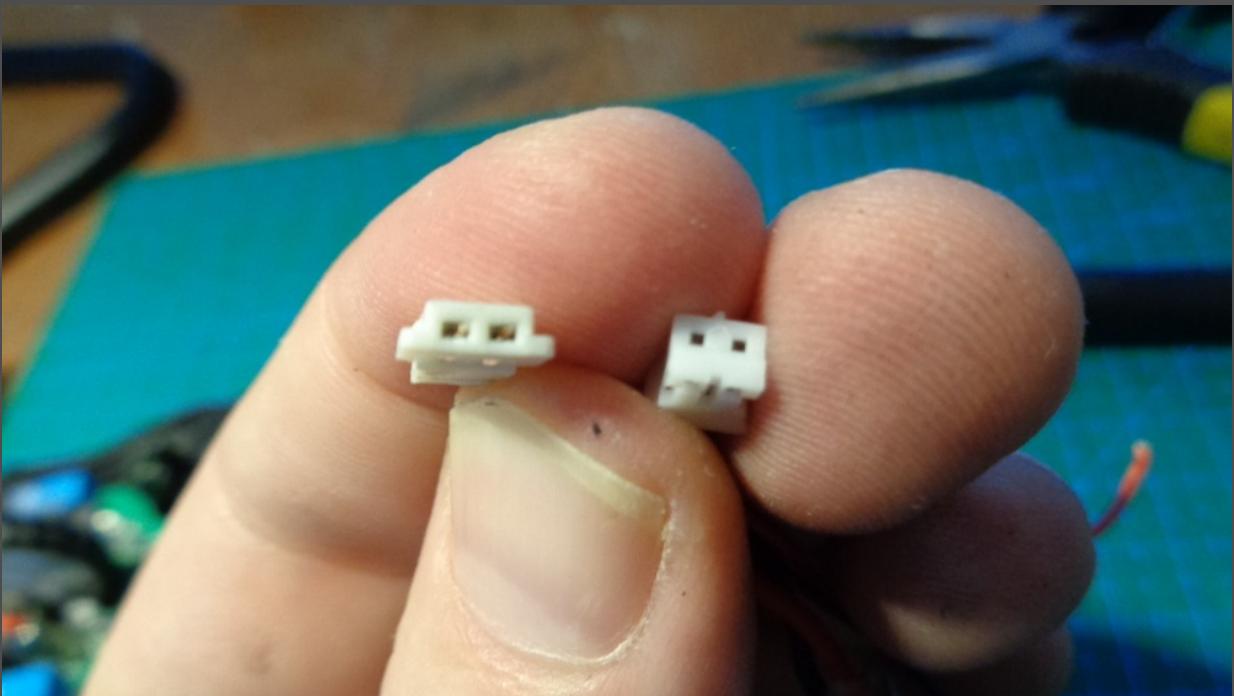
Unfortunately it turned out that the old plug did not match the plug of the battery. But that gave me another idea. If I solder both plugs to the battery, I can use the charger cable of my old drone from which I took the battery. So I wouldn't have to remove the plug from the mouse and connect it with the cable, but would have a permanent connection between PCB and battery.
